MRI-Induced Burns from ECG Leads:
Thermal or Electrical Burns?

Burns and Plastic Surgery Unit, Nottingham University Hospitals NHS Trust, UK

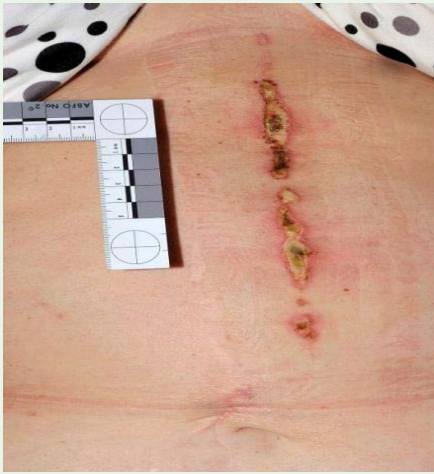
On emergence from the anesthetic, the patient started complaining of a burning sensation on her anterior chest and abdominal wall. On further examination, there was an erythematous, blistering line radiating from the xyphoid process to a few centimeters above the umbilicus, approximately 1cm in width (Figure 1). The line and pattern corresponded to a burn from a braided 3-lead ECG.

Figure 1: An erythematous, blistering line radiating from the xyphoid process to a few centimeters above the umbilicus, approximately 1cm in width.

Cold swabs were immediately applied to the burnt area, analgesia, and 500 IUs booster dose of human immunoglobulins for tetanus were given. The patient was then transferred to our burns unit. She sustained 0.2% superficial partial thickness burn of her Total Body Surface Area (TBSA). She remained hemodynamically stable and afebrile. Laboratory investigations revealed hemoglobin 12g/dL, white cell count $13 \times 10^9/L$, neutrophils 8.3, platelets $849 \times 10^9/L$, sodium 137mmol/L, potassium 4.6mmol/L, Urea 9.7mmol/L and creatinine 135mmol/L. ECG and other investigations, including urine myoglobinuria, were all unremarkable. Urgent plain abdominal radiograph and abdominal ultrasound were ordered, both of which excluded intra-abdominal visceral injury that may have occurred from old metallic surgical clips. The patient was therefore treated conservatively with Urgotul® SSD dressing and gauze. She appeared to be clinically dehydrated and was subsequently prescribed 1litre of Hartmann's solution over 4 hours, followed by 1litre over 8hours. The patient made an uneventful recovery and was discharged within 24 hours of admission, with one week follow up at the out-patient dressing clinic.

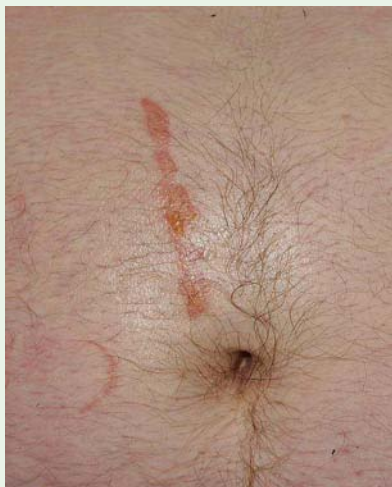
Figure 2: A linear pattern of erythematous and blistered skin measuring approximately eight centimeters long on the anterior abdominal wall.

Total duration of MR scanning lasted 30 minutes. Upon waking from anesthesia, the patient started to complain of pain around umbilical region. Physical examination revealed a linear pattern of erythematous and blistered skin measuring approximately eight centimeters long on the anterior abdominal wall (Figure 2). Because of our experience with the previous case we suspected that his burns were induced by ECG cables. First aid measures included application of cold swabs and burn injury was treated conservatively with conventional burn dressings.
